**Flood Control Project Maintenance  
Levee Inspections**

**Fall 2018 Levee Maintenance Deficiency Summary Report**

**Sacramento River Basin**

**Lake County Watershed Protection District**

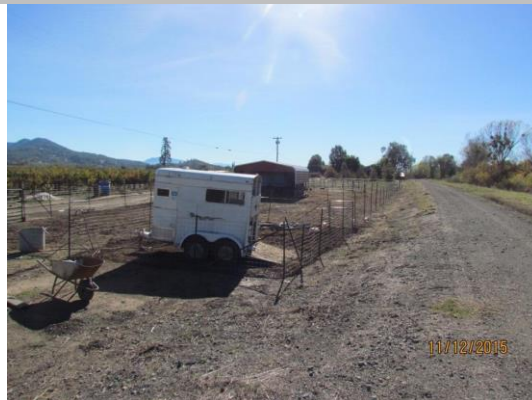
Photo 1 of 1 : FA\_2018\_NA0009\_3\_24\_20180905\_00012.jpg

LM Start	0.14	Rating **	M	Issue No.	24
LM End	0.22	Issue Type +	En	Location *	LS
Category	Earthen Levee			GPS Latitude/Longitude	
				Start	End
Item	Encroachments			39.188465 °	39.187392 °
				-122.907687 °	-122.907885 °
DWR ID	DWR_NA0009_01_f_2015_24				
Comment Code					
FE : Fence					
Inspector Comment					
Remove the fence from the landside toe.

View of the fence along the landside toe.

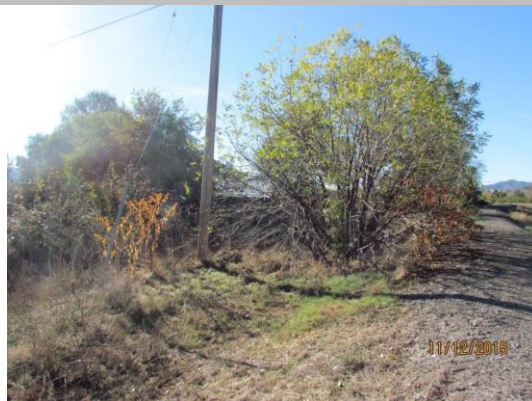
Photo 1 of 1 : FA\_2018\_NA0009\_3\_11\_20180905\_00006.jpg

LM Start	0.26	Rating **	M	Issue No.	11
LM End	0.26	Issue Type +	Ma	Location *	LS
Category	Earthen Levee			GPS Latitude/Longitude	
				Start	End
Item	Trim / Thin Trees			39.186777°	39.186777°
				-122.908102°	-122.908102°
DWR ID	DWR_NA0009_01_s_2013_11				
Comment Code					
T3 : Trim and thin trees to allow visibility of the ground and room to flood fight.					
Inspector Comment

View of the overgrown trees at the landside slope.

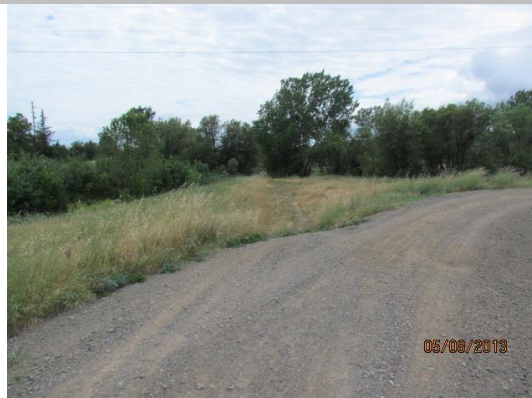
Photo 1 of 1 : FA\_2018\_NA0009\_3\_13\_20180905\_00007.jpg

LM Start	2.29	Rating **	M	Issue No.	13
LM End	2.29	Issue Type +	Ma	Location *	WS
Category	Earthen Levee			GPS Latitude/Longitude	
				Start	End
Item	Slope Stability			39.160285 °	39.160285 °
				-122.913481 °	-122.913481 °
DWR ID	DWR_NA0009_01_s_2013_13				
Comment Code					
S3 : Repair the levee slope damaged by vehicle traffic and prevent access where possible.					
Inspector Comment

View of the vehicle erosion along the waterside slope.

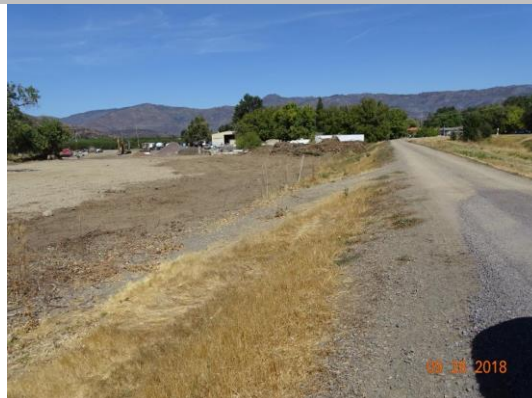
Photo 1 of 1 : FA\_2018\_NA0009\_3\_28\_20181009\_00035.jpg

LM Start	2.30	Rating **	A	Issue No.	28
LM End	2.37	Issue Type +	Ma	Location *	LS
Category	Earthen Levee			GPS Latitude/Longitude	
				Start	End
Item	Vegetation			39.160383 °	39.161275 °
				-122.913252 °	-122.912627 °
DWR ID	DWR_NA0009_01_f_2018_28				
Comment Code					
V1 : Control annual grass and weeds on the levee slopes and easements.					
Inspector Comment					
The vegetation was removed from both slopes.

View of no vegetation on both slopes.

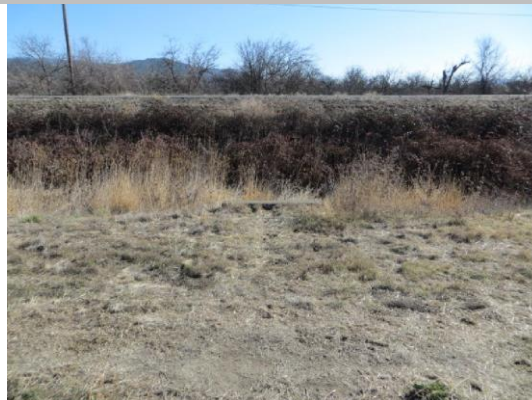
Photo 2 of 3 : UCIP\_FA\_2018\_27004\_49861.jpg

LM Start	2.35	Rating **	M	Issue No.	539 (cont)
LM End	2.35	Issue Type +	Ma	Location *	
Category	Supplemental			GPS Latitude/Longitude	
				Start	End
Item	DWR UCIP LMA Responsibility			39.161002 °	39.161002 °
				-122.912843 °	-122.912843 °
DWR ID	21199				
Comment Code					
Inspector Comment					
FS_ID:27004 DS_ID:21199 EP_NO: 11460 Repair Type: Non-Urgent Crossing Status: Found UCIP Comments: Heavy vegetation on LS at inlet should be removed. FIELD_STRUCT_DESC: 42-inch corrugated metal drainage pipe through the levee, 10 feet below the crown. Flap gate on the waterside (WS) end. Concrete headwall on both ends. (42-inch pipe [HLM 2.35] retained under Automatic Board Order (ABO) issued as Permit No. 11460, 1975 - Robert L. and Lavona Gentry). [Additional Reference(s): DWR Levee Log, 2005. USACE Sacramento O&M Manual 506.2, August 1961, (HLM 2.35)]. FS Date: 1/14/2014

Concrete U-shaped headwall on WS berm.

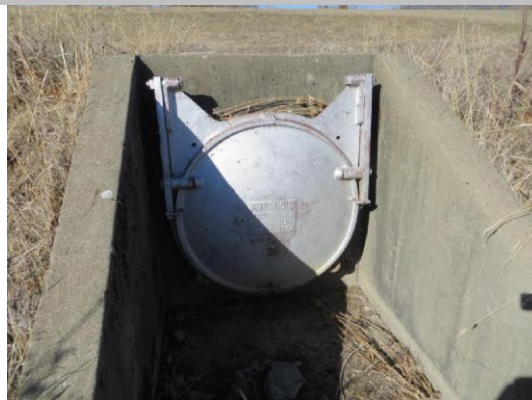
Photo 3 of 3 : UCIP\_FA\_2018\_27004\_49860.jpg

Concrete U-shaped headwall and flap gate on WS berm.

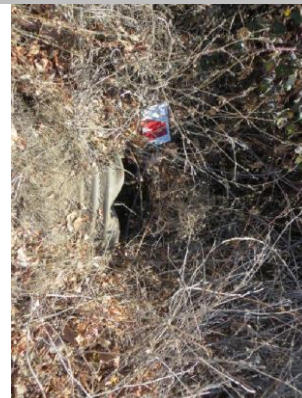
Photo 1 of 3 : UCIP\_FA\_2018\_53326\_50042.jpg

Comment Code						
Inspector Comment						
FS_ID:53326 DS_ID:21200 EP_NO: 11458 Repair Type: Urgent Crossing Status: Found UCIP Comments: 9/6/2018 Inspected this crossing per the request of LMA Rep, Scott Webb. WS pipe does not have a WS closure device and has caused flooding of the roadway due to the flat LS pipe slope and roadway. Classifying Urgent until the flooding risk is reduced by the installation of a WS gate valve (D. Sanoski - DWR UCIP). FIELD_STRUCT_DESC: 36-inch corrugated metal drainage pipe through the levee, 8 feet below the crown. 24-inch by 36-inch drainage drop inlet visible at edge of pavement on Highway 20. Open on the waterside (WS) end. (Pipe retained through the levee under Automatic Board Order (ABO) issued as Permit No. 11458, 1975 - Fernande and Guido Deghetaldi). [Additional Reference(s): DWR Levee Log, 2005]. FS Date: 9/6/2018 1:04:00 PM

Outlet visible on WS toe.

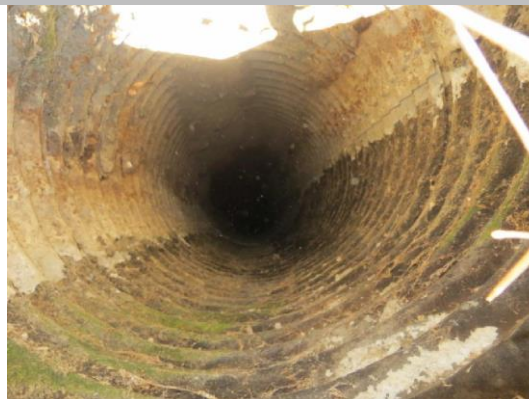
Photo 2 of 3 : UCIP\_FA\_2018\_53326\_50041.jpg

Some rust on inside of CMP pipe at WS toe.

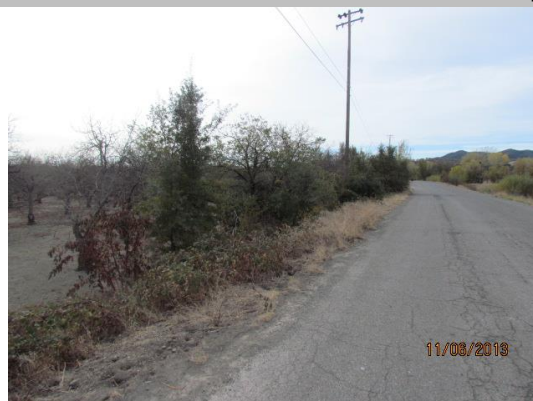
Photo 1 of 2 : FA\_2018\_NA0009\_3\_3\_20180905\_00001.jpg

LM Start	2.48	Rating **	U	Issue No.	3
LM End	2.55	Issue Type +	Ma	Location *	LS
Category	Earthen Levee			GPS Latitude/Longitude	
				Start	End
Item	Vegetation			39.161615 °	39.160804 °
				-122.911733 °	-122.912536 °
DWR ID	DWR_NA0009_01_s_2012_3				
Comment Code					
V2 : Remove the wild growth other than native grasses from the levee slopes.					
Inspector Comment

View of the vegetation along the landside slope.

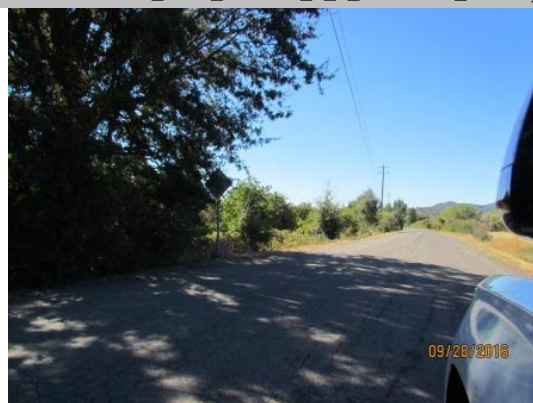
Photo 2 of 2 : FA\_2018\_NA0009\_3\_3\_20180905\_00002.jpg

View of the vegetation along the landside slope.

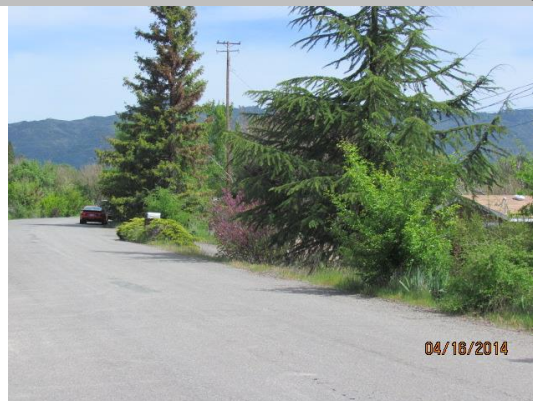
Photo 1 of 1 : FA\_2018\_NA0009\_3\_5\_20180905\_00004.jpg

LM Start	2.58	Rating **	M	Issue No.	5
LM End	2.66	Issue Type +	En	Location *	LS
Category	Earthen Levee			GPS Latitude/Longitude	
				Start	End
Item	Vegetation			39.160443 °	39.159308 °
				-122.912845 °	-122.913417 °
DWR ID	DWR_NA0009_01_s_2012_5				
Comment Code					
V6 : Landscaping					
Inspector Comment

View of the landscape along the landside slope.

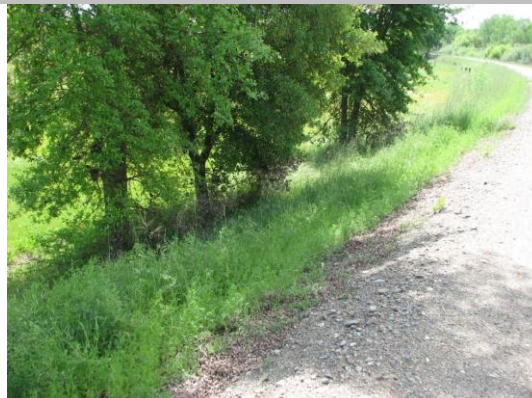
Photo 1 of 1 : FA\_2018\_NA0009\_3\_25\_20180905\_00013.jpg

LM Start	2.95	Rating **	M	Issue No.	25
LM End	2.95	Issue Type +	Ma	Location *	LS
Category	Earthen Levee			GPS Latitude/Longitude	
				Start	End
Item	Trim / Thin Trees			39.155301 °	39.155301 °
				-122.914633 °	-122.914633 °
DWR ID	DWR_NA0009_01_s_2016_25				
Comment Code					
T1 : Trim trees to at least five feet above ground level.					
Inspector Comment

Trim trees to 5' above levee slope (LS). 4/19/2016

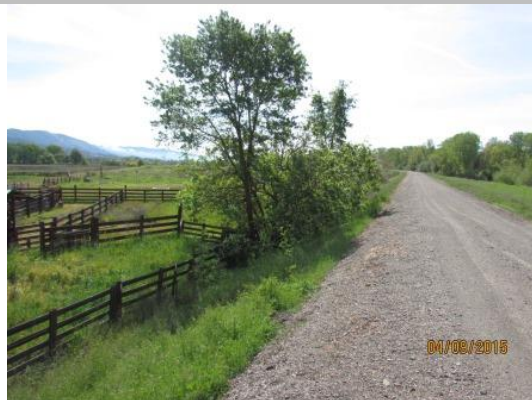
Photo 1 of 1 : FA\_2018\_NA0009\_3\_534\_20180905\_00017.jpg

LM Start	3.26	Rating **	M	Issue No.	534
LM End	3.26	Issue Type +	Ma	Location *	LS
Category	Earthen Levee			GPS Latitude/Longitude	
				Start	End
Item	Trim / Thin Trees			39.150957°	39.150957°
				-122.913504°	-122.913504°
DWR ID	DWR_NA0009_01_s_2015_534				
Comment Code					
T2 : Thin trees to allow visibility of the ground and room to flood fight.					
Inspector Comment

Remove the trees from the landside toe.

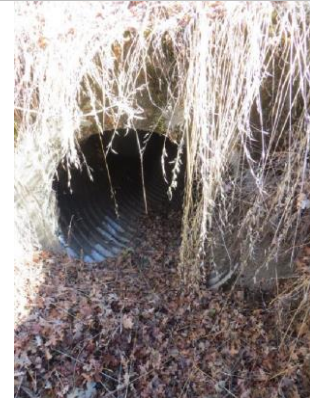
Photo 2 of 3 : UCIP\_FA\_2018\_27066\_50048.jpg

Pipe and headwall visible at LS toe in drainage swale.

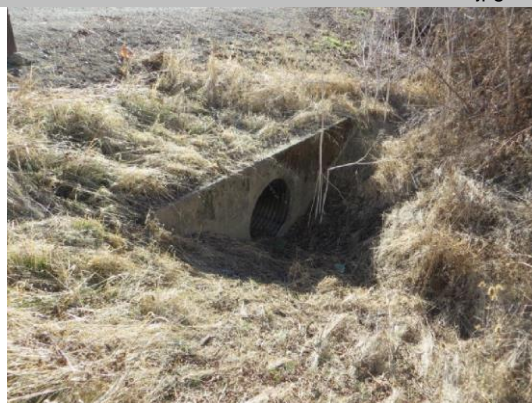
Photo 1 of 3 : UCIP\_FA\_2018\_27184\_50322.jpg

Concrete headwall and pipe on LS toe.

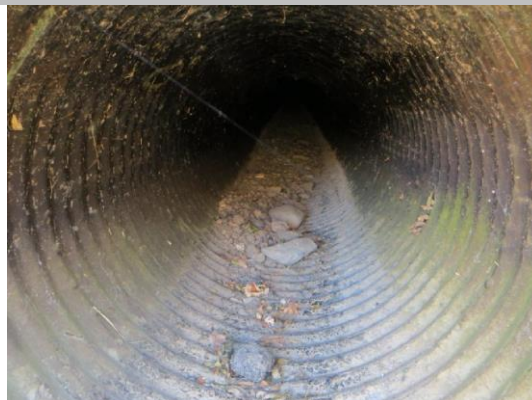
Photo 2 of 3 : UCIP\_FA\_2018\_27184\_50321.jpg

Pipe at inlet.

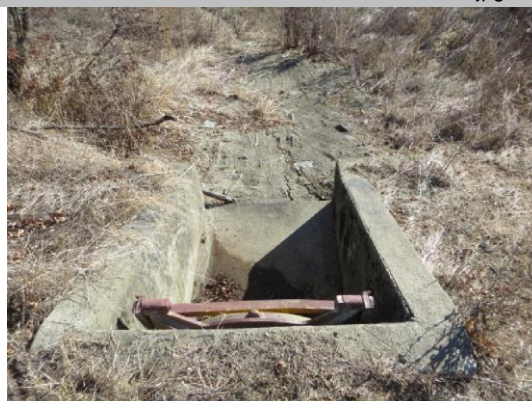
Photo 3 of 3 : UCIP\_FA\_2018\_27184\_50320.jpg

LM Start	0.24	Rating **	A/W	Issue No.	34 (cont)	
LM End	0.24	Issue Type +	Ma	Location *		
Category	Supplemental			GPS Latitude/Longitude		
				Start		End
Item	DWR UCIP LMA Responsibility			39.186794 °	39.186794 °	
				-122.909413 °	-122.909413 °	
DWR ID	21204					
Comment Code						
Inspector Comment						
FS_ID:27184 DS_ID:21204 EP_NO: 11484 Repair Type: No Action Needed Crossing Status: Found UCIP Comments: FIELD_STRUCT_DESC: 36-inch corrugated metal drainage pipe through the levee, 6 feet below the crown. Flap gate on the waterside (WS) end. Concrete headwalls on both ends. (36-inch pipe [HLM 0.23] retained under Automatic Board Order (ABO) issued as Permit No. 11484, 1975 - Rodney Snow). [Additional Reference(s): DWR Levee Log, 2005. USACE Sacramento O&M Manual 506.2, August 1961, (HLM 0.23)]. FS Date: 1/14/2014

Flapgate and concrete headwall on WS toe.

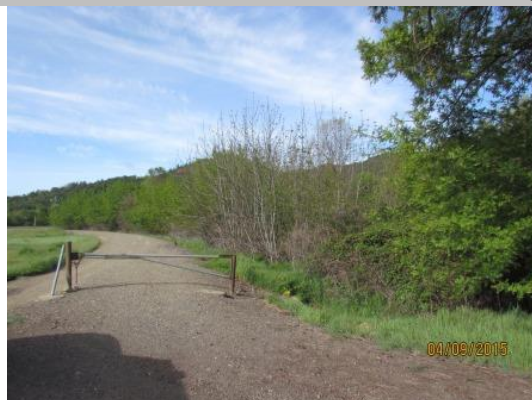
Photo 1 of 1 : FA\_2018\_NA0009\_4\_9\_20180905\_00006.jpg

LM Start	0.24	Rating **	M	Issue No.	9
LM End	0.27	Issue Type +	Ma	Location *	LS
Category	Earthen Levee			GPS Latitude/Longitude	
				Start	End
Item	Trim / Thin Trees			39.186739 °	39.186389 °
				-122.909436 °	-122.909821 °
DWR ID	DWR_NA0009_02_s_2013_9				
Comment Code					
T1 : Trim trees to at least five feet above ground level.					
Inspector Comment

View of the overgrown trees and vegetation at the landside toe.

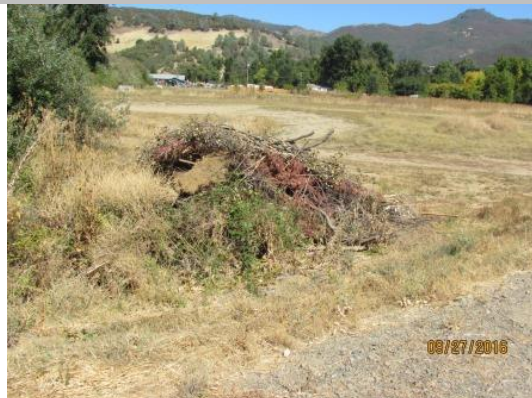
Photo 1 of 1 : FA\_2018\_NA0009\_4\_17\_20180905\_00008.jpg

LM Start	0.38	Rating **	M	Issue No.	17
LM End	0.38	Issue Type +	En	Location *	LS
Category	Earthen Levee			GPS Latitude/Longitude	
				Start	End
Item	Encroachments			39.185239 °	39.185239 °
				-122.911018 °	-122.911018 °
DWR ID	DWR_NA0009_02_f _ 2016_17				
Comment Code					
PR : Prunings					
Inspector Comment

View of the prunings along the landside toe.

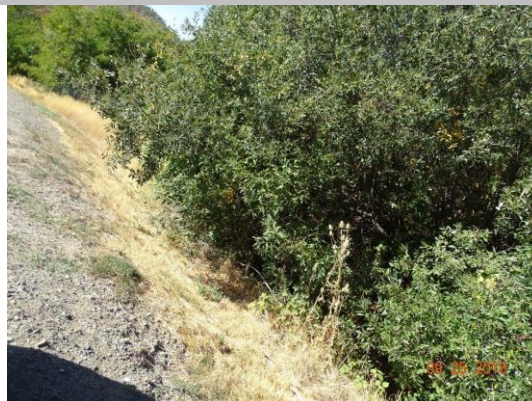
Photo 1 of 1 : FA\_2018\_NA0009\_4\_29\_20181009\_00050.jpg

LM Start	0.38	Rating **	M	Issue No.	29
LM End	0.38	Issue Type +	Ma	Location *	LS
Category	Earthen Levee			GPS Latitude/Longitude	
				Start	End
Item	Trim / Thin Trees			39.185208 °	39.185208 °
				-122.911065 °	-122.911065 °
DWR ID	DWR_NA0009_02_f_2018_29				
Comment Code					
T2 : Thin trees to allow visibility of the ground and room to flood fight.					
Inspector Comment					
Trim and thin the trees up at least 5 feet to allow visibility.

View of the trees along the landside slope and toe.

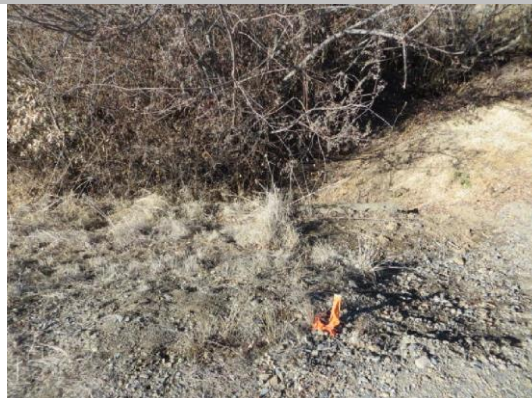
Photo 1 of 3 : UCIP\_FA\_2018\_27192\_50326.jpg

Pipe and concrete headwall at LS toe.

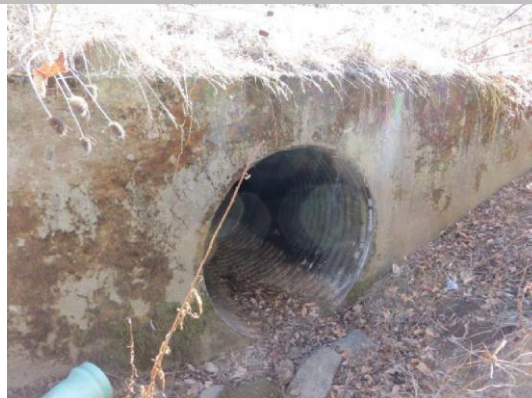
Photo 3 of 3 : UCIP\_FA\_2018\_27192\_50324.jpg

Comment Code						
Inspector Comment						
FS_ID:27192						
DS_ID:21206						
EP_NO: 11478						
Repair Type: No Action Needed						
Crossing Status: Found						
UCIP Comments:						
FIELD_STRUCT_DESC: 42-inch corrugated metal drainage pipe through the levee, 7.7 feet below the crown. Flap gate on the waterside (WS) end. Concrete headwalls on both ends. Grouted spillway over revetment on bank. (42-inch pipe [HLM 0.38] retained under Automatic Board Order (ABO) issued as Permit No. 11478, 1975 - William D. and Dorothy L. Allison). [Additional Reference(s): DWR Levee Log, 2005. USACE Sacramento O&M Manual 506.2, August 1961, (HLM 0.38)].						
FS Date: 1/14/2014

Pipe and concrete headwall at LS toe.

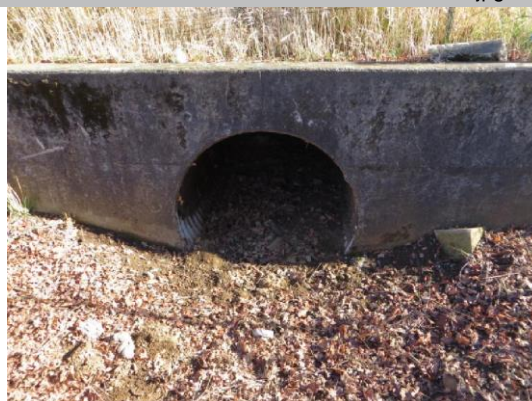
Photo 1 of 3 : UCIP\_FA\_2018\_27199\_50389.jpg

LM Start	0.48	Rating **	A/W	Issue No.	36
LM End	0.48	Issue Type +	Ma	Location *	
Category	Supplemental			GPS Latitude/Longitude	
				Start	End
Item	DWR UCIP LMA Responsibility			39.184126°	39.184126°
				-122.912118°	-122.912118°
DWR ID	21208				
Comment Code					
Inspector Comment					
FS_ID:27199					
DS_ID:21208					
EP_NO: 11480					
Repair Type: No Action Needed					
Crossing Status: Found					
UCIP Comments:					
FIELD_STRUCT_DESC: 42-inch corrugated metal drainage pipe through the levee, 7 feet below the crown. Flap gate on the waterside (WS) end. Concrete headwalls on both ends. (42-inch pipe [HLM 0.47] retained under Automatic Board Order (ABO) issued as Permit No. 11480, 1975 - Jose G. and Dora Moto). [Additional Reference(s): DWR Levee Log, 2005. USACE Sacramento O&M Manual 506.2, August 1961, (HLM 0.47)].					
FS Date: 1/14/2014

Concrete headwall on LS toe.

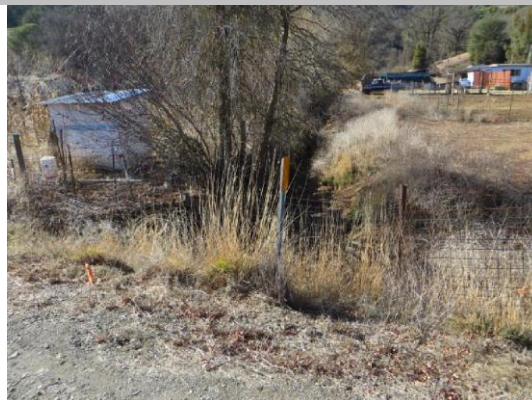
Photo 2 of 3 : UCIP\_FA\_2018\_27199\_50388.jpg

Pipe and concrete headwall on LS toe.

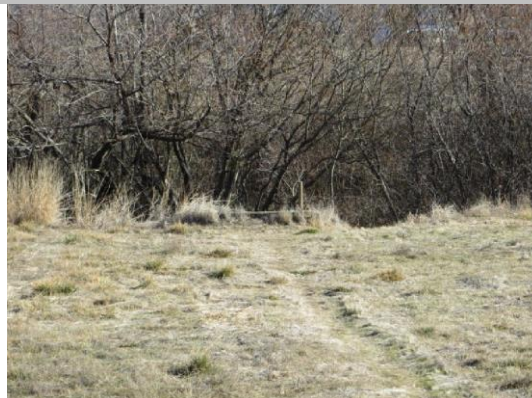
Photo 3 of 3 : UCIP\_FA\_2018\_27199\_50387.jpg

Concrete headwall and flapgate visible on waterside berm

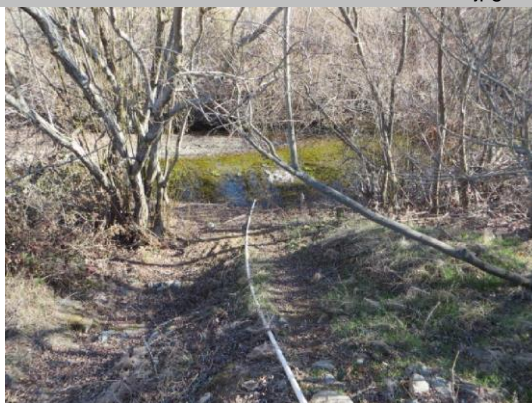
Photo 2 of 3 : UCIP\_FA\_2018\_27563\_51181.jpg

Pipe visible just downstream from stormdrain.

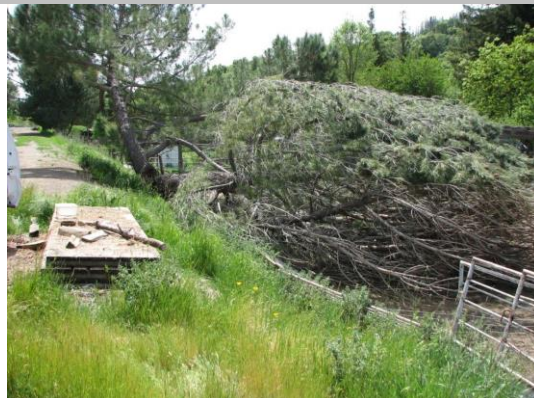
Photo 1 of 1 : FA\_2018\_NA0009\_4\_20\_20180905\_00010.jpg

LM Start	0.49	Rating **	M	Issue No.	20
LM End	0.49	Issue Type +	Ma	Location *	LS
Category	Earthen Levee			GPS Latitude/Longitude	
				Start	End
Item	Trim / Thin Trees			39.184001 °	39.184001 °
				-122.912139 °	-122.912140 °
DWR ID	DWR_NA0009_02_s_2016_20				
Comment Code					
T2 : Thin trees to allow visibility of the ground and room to flood fight.					
Inspector Comment					
Remove large downed pine tree branch on LS toe.

View of the fallen tree branch on landside slope and toe.

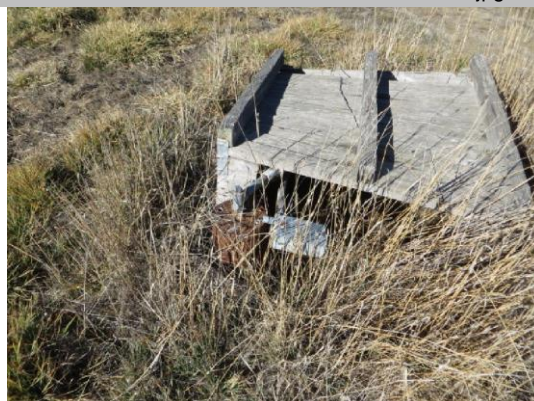
Photo 1 of 3 : UCIP\_FA\_2018\_52935\_50393.jpg

Comment Code					
Inspector Comment					
FS_ID:52935 DS_ID:21209 EP_NO: 8513 Repair Type: Non-Urgent Crossing Status: Found UCIP Comments: 9/6/2018 Pump no longer in operation. Downgraded from Urgent to Non-Urgent (D. Sanoski - DWR UCIP).11/30/2016 Pipe not in use per LMA representative, Scott Webb. DWR Fall inspection 2016 indicated depression along pipe alignment. According to LMA representative the new property owner is Tracy Joe Hill. Need to contact owner. New owner will need to coordinate with CVFPB regarding permit name change and to address depression noted in the 2016 DWR Fall Inspection . (O. Magana - DWR UCIP)01/14/2014 Appears pipe is leaking on WS toe of Levee at mud pit. (W. Wylie - DWR UCIP) FIELD_STRUCT_DESC: 1 of 2: 1.25-inch steel groundwater pipe through the levee, 2 feet below the levee. Steel cutoff wall around pipe at center of levee. Well with 8-inch casing on waterside (WS) slope. (1.25-inch water pipe and 0.75-inch electrical conduit authorized under Permit No. 8513, 1974 - Fisher) FS Date: 9/6/2018 12:53:24 PM

Pump and pipe visible at wooden box on WS berm.

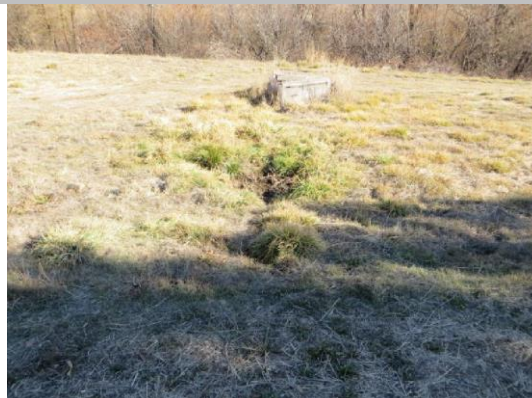
Photo 2 of 3 : UCIP\_FA\_2018\_52935\_50392.jpg

Mudpit at WS berm where pipe may be leaking.

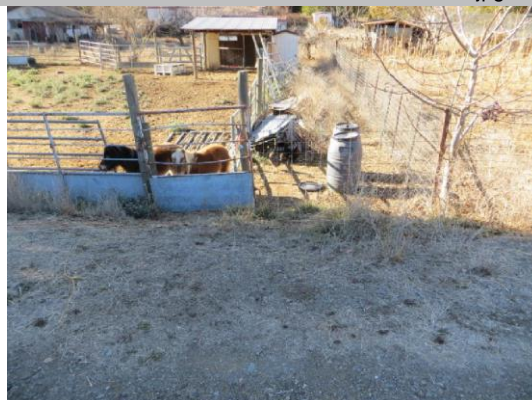
Photo 3 of 3 : UCIP\_FA\_2018\_52935\_50391.jpg

Valves visible just off LS toe.

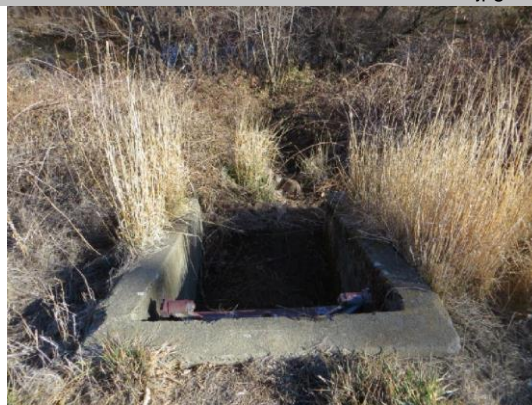
Photo 2 of 3 : UCIP\_FA\_2018\_27208\_50410.jpg

Flapgate and concrete headwall on WS berm.

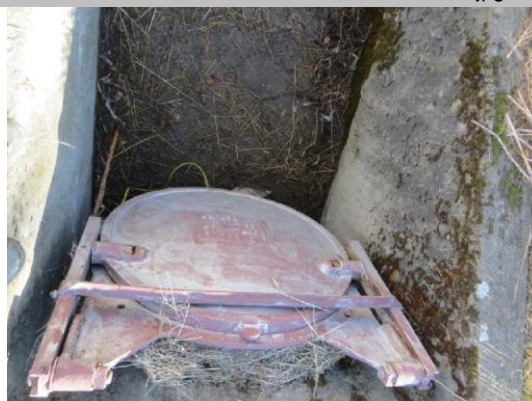
Photo 3 of 3 : UCIP\_FA\_2018\_27208\_50409.jpg

Flapgate and concrete headwall on WS berm.

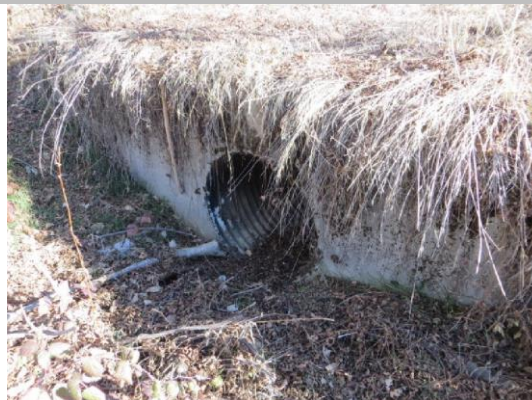
Photo 1 of 3 : UCIP\_FA\_2018\_27583\_51202.jpg

LM Start	1.03	Rating **	A/W	Issue No.	40
LM End	1.03	Issue Type +	Ma	Location *	
Category	Supplemental			GPS Latitude/Longitude	
				Start	End
Item	DWR UCIP LMA Responsibility			39.176366 °	39.176366 °
				-122.913509 °	-122.913509 °
DWR ID	21211				
Comment Code					
Inspector Comment					
FS_ID:27583 DS_ID:21211 EP_NO: 11486 Repair Type: No Action Needed Crossing Status: Found UCIP Comments: FIELD_STRUCT_DESC: 36-inch corrugated metal drainage pipe through the levee, 7.3 feet below the crown. Flap gate on the waterside (WS) end. Concrete headwalls on both ends. Splash apron broken off on the WS end. (36-inch pipe [HLM 1.08] retained under Automatic Board Order (ABO) issued as Permit No. 11486, 1975 - Mary Truesdell). [Additional Reference(s): DWR Levee Log, 2005. USACE Sacramento O&M Manual 506.2, August 1961, (HLM 1.08) Drawing No. CC-4-4-29]. FS Date: 1/22/2014

Pipe visible at concrete inlet on LS toe.

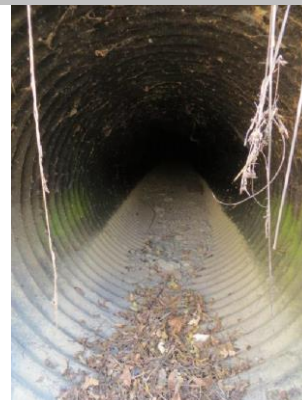
Photo 2 of 3 : UCIP\_FA\_2018\_27583\_51201.jpg

Pipe as visible from LS toe.

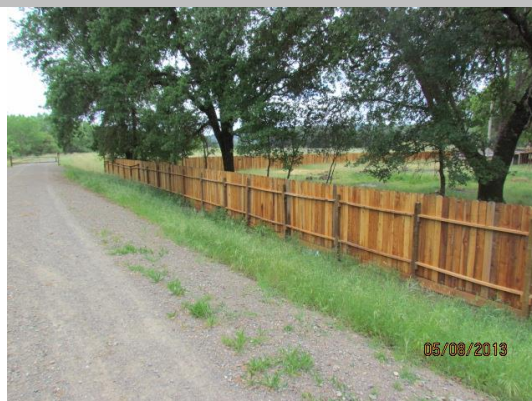
Photo 1 of 1 : FA\_2018\_NA0009\_4\_10\_20180905\_00007.jpg

LM Start	1.09	Rating **	U	Issue No.	10
LM End	1.11	Issue Type +	En	Location *	LS
Category	Earthen Levee			GPS Latitude/Longitude	
				Start	End
Item	Encroachments			39.175460 °	39.175075 °
				-122.913400 °	-122.913392 °
DWR ID	DWR_NA0009_02_s_2013_10				
Comment Code					
FE : Fence					
Inspector Comment

View of the unauthorized fence along the landside toe.

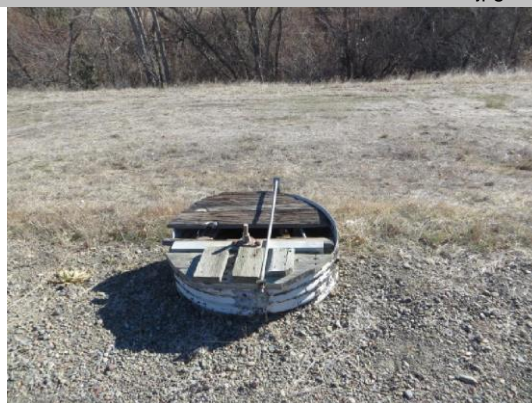
Photo 1 of 3 : UCIP\_FA\_2018\_42994\_51214.jpg

Comment Code					
Inspector Comment					
FS_ID:42994 DS_ID:21212 EP_NO: 11483 Repair Type: Non-Urgent Crossing Status: Found UCIP Comments: Pipe appears abandoned and if so, should be done so properly. Debris blocking flapgate at outlet. FIELD_STRUCT_DESC: *ABANDONED* 30-inch corrugated metal drainage pipe through the levee, 17.8 feet below the crown. Slide gate in 44-inch corrugated metal riser unit on the waterside (WS) slope. Flap gate on the WS end at concrete headwall. 6-foot by 8-foot concrete sump at the landside (LS) toe. (30-inch pipe [HLM 1.22] retained under Automatic Board Order (ABO) issued as Permit No. 11483, 1975 - Edward M. and Mildred E. Seely). [Additional Reference(s): DWR Levee Log, 2005. USACE Sacramento O&M Manual 506.2, August 1961, (HLM 1.22)]. FS Date: 1/22/2014

Slide gate in 44-inch CMP riser on WS shoulder.

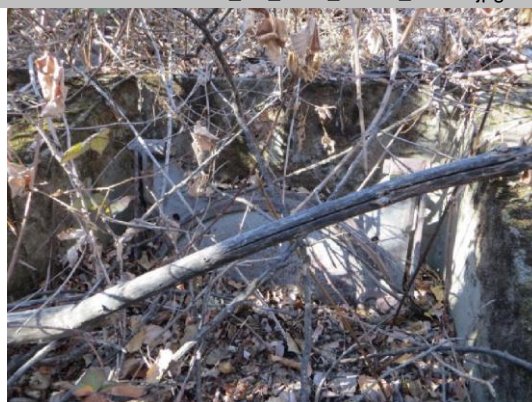
Photo 3 of 3 : UCIP\_FA\_2018\_42994\_51215.jpg

Flapgate and concrete headwall visible off WS berm.

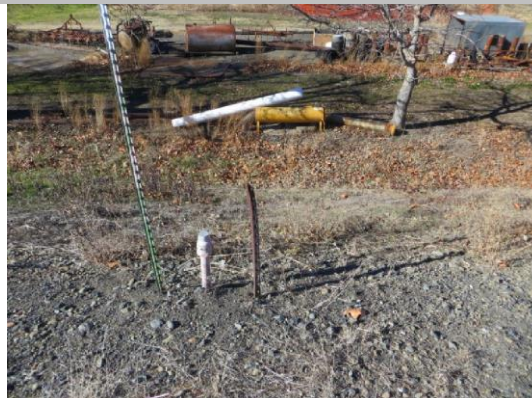
Photo 1 of 2 : UCIP\_FA\_2018\_27606\_51250.jpg

LM Start	1.70	Rating **	M	Issue No.	42
LM End	1.70	Issue Type +	En	Location *	
Category	Supplemental			GPS Latitude/Longitude	
				Start	End
Item	DWR UCIP Field Study			39.167156°	39.167156°
				-122.916610°	-122.916610°
DWR ID	21214				
Comment Code					
Inspector Comment					
FS_ID:27606 DS_ID:21214 EP_NO: 15825 Repair Type: Non-Urgent Crossing Status: Found UCIP Comments: Pipe with closure device not visible on WS toe. Clear soil from pipe and cover for better verification of closure. FIELD_STRUCT_DESC: 8-inch steel irrigation pipe through the levee, 2 feet below the crown. Siphon breaker on apex of pipe at the landside (LS) shoulder. Exposed filter on LS slope. Seasonal pump on the waterside (WS) slope. (Permit No. 15825, 1992 - Edward Seely). [Additional Reference(s): DWR Levee Log, 2005]. FS Date: 1/22/2014

Vent on LS shoulder with filter visible on LS toe.

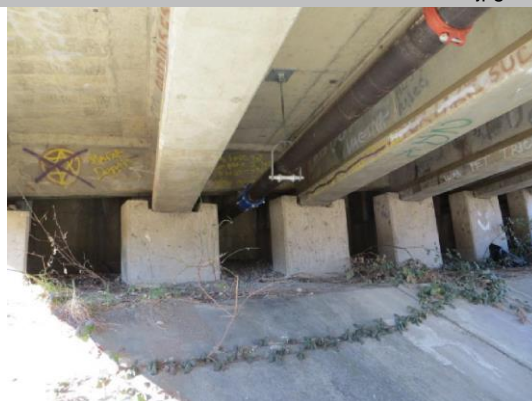
Photo 1 of 2 : UCIP\_FA\_2018\_27624\_51263.jpg

FS\_ID:27624  
DS\_ID:21243  
EP\_NO: 15865  
Repair Type: Non-Urgent  
Crossing Status: Found  
UCIP Comments: Permit number likely revised from 15865. Verify with inspector and modify entry as required.  
FIELD\_STRUCT\_DESC: 8-inch steel pressurized sewer line through the levee, 3 feet below the crown. Cutoff wall around pipe at center of levee. Siphon breaker on the waterside (WS) shoulder. Pipe visible under bridge. (Permit No. 15865, 1992 - Zachary Calhoun).  
FS Date: 1/22/2014

Pipe visible under bridge.

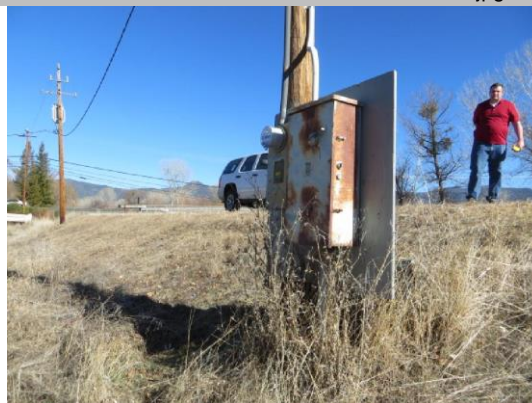
Photo 2 of 2 : UCIP\_FA\_2018\_27629\_51279.jpg

Meter and control on LS slope next to pole.

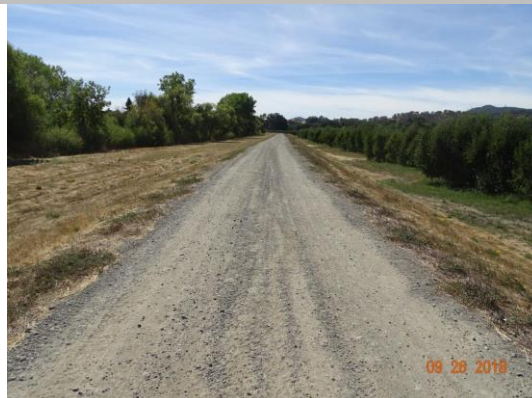
Photo 1 of 1 : FA\_2018\_NA0009\_4\_32\_20181009\_00052.jpg

LM Start	2.33	Rating **	A	Issue No.	32
LM End	2.33	Issue Type +	Ma	Location *	LS
Category	Earthen Levee			GPS Latitude/Longitude	
				Start	End
Item	Vegetation			39.158490 °	39.158490 °
				-122.914688 °	-122.914688 °
DWR ID	DWR_NA0009_02_f_2018_32				
Comment Code					
V1 : Control annual grass and weeds on the levee slopes and easements.					
Inspector Comment					
The vegetation was removed from both slopes.

View of no vegetation on both slopes.

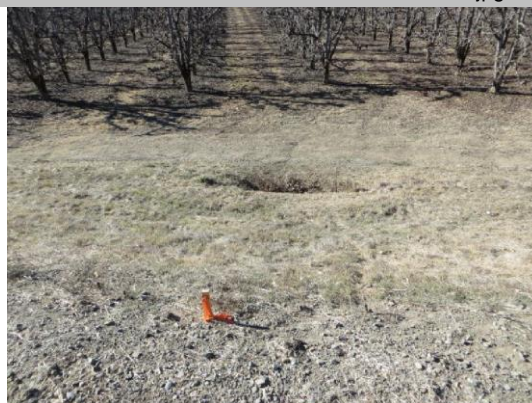
Photo 1 of 3 : UCIP\_FA\_2018\_27630\_51283.jpg

LM Start	2.84	Rating **	M	Issue No.	46
LM End	2.84	Issue Type +	Ma	Location *	
Category	Supplemental			GPS Latitude/Longitude	
				Start	End
Item	DWR UCIP LMA Responsibility			39.151257°	39.151257°
				-122.914908°	-122.914908°
DWR ID	21215				
Comment Code					
Inspector Comment					
FS_ID:27630					
DS_ID:21215					
EP_NO: 11481					
Repair Type: Non-Urgent					
Crossing Status: Found					
UCIP Comments: Soil partially blocking inlet and outlet.					
FIELD_STRUCT_DESC: 24-inch corrugated metal drainage pipe through the levee, 12 feet below the crown. Flap gate on the waterside (WS) end. Concrete headwalls on both ends. (24-inch pipe [HLM 2.93] retained under Automatic Board Order (ABO) issued as Permit No. 11481, 1975 - Dennis P. McCarthy). [Additional Reference(s): DWR Levee Log, 2005. USACE Sacramento O&M Manual 506.2, August 1961, (HLM 2.93)].					
FS Date: 1/22/2014

Concrete headwall and pipe visible at LS toe.

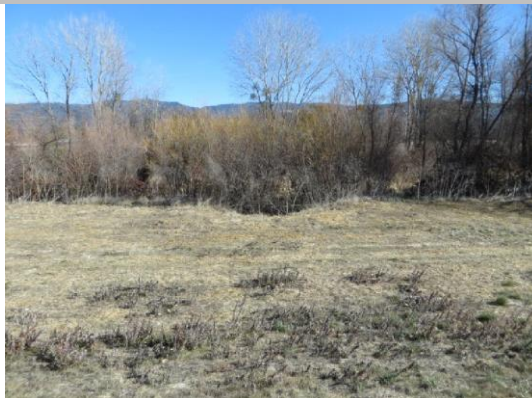
Photo 2 of 3 : UCIP\_FA\_2018\_27630\_51282.jpg

Concrete headwall and flapgate visible at WS berm.

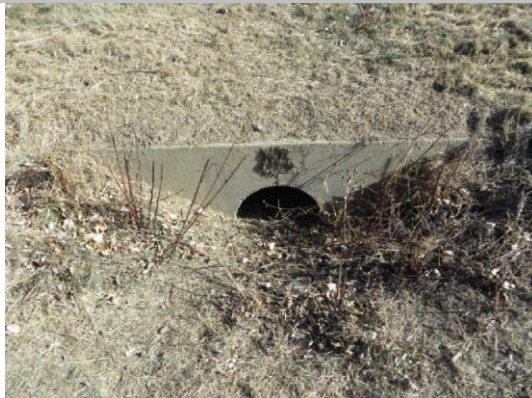
Photo 3 of 3 : UCIP\_FA\_2018\_27630\_51281.jpg

Concrete headwall and pipe visible at LS toe.

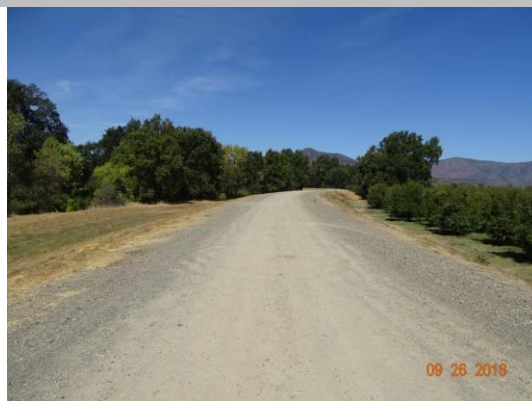
Photo 1 of 1 : FA\_2018\_NA0009\_5\_20\_20181009\_00042.jpg

LM Start	0.32	Rating **	A	Issue No.	20
LM End	0.32	Issue Type +	Ma	Location *	LS
Category	Earthen Levee			GPS Latitude/Longitude	
				Start	End
Item	Vegetation			39.151917 °	39.151917 °
				-122.917188 °	-122.917188 °
DWR ID	DWR_NA0009_03_f_2018_20				
Comment Code					
V1 : Control annual grass and weeds on the levee slopes and easements.					
Inspector Comment					
The vegetation was removed from both slopes.

View of no vegetation on both slopes.

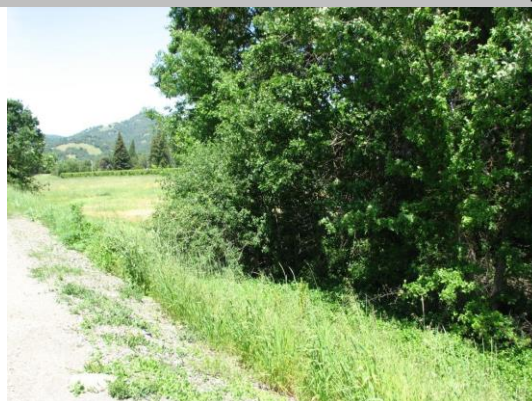
Photo 1 of 1 : FA\_2018\_NA0009\_5\_9\_20180905\_00001.jpg

LM Start	0.49	Rating **	M	Issue No.	9
LM End	0.49	Issue Type +	Ma	Location *	LS
Category	Earthen Levee			GPS Latitude/Longitude	
				Start	End
Item	Vegetation			39.154195°	39.154195°
				-122.918134°	-122.918134°
DWR ID	DWR_NA0009_03_s_2016_9				
Comment Code					
V2 : Remove the wild growth other than native grasses from the levee slopes.					
Inspector Comment

View of the overgrown trees and vegetation at the landside toe.

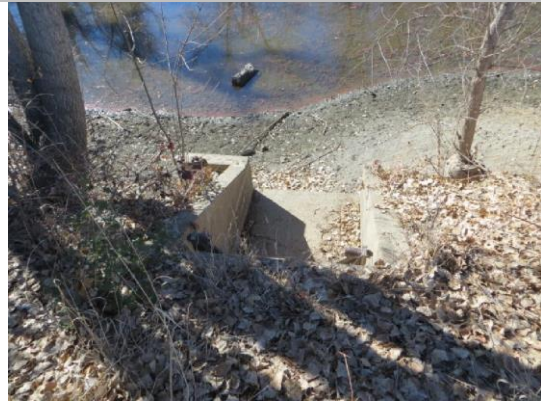
Photo 2 of 3 : UCIP\_FA\_2018\_27863\_51541.jpg

Comment Code						
Inspector Comment						
FS_ID:27863 DS_ID:21217 EP_NO: 11492 Repair Type: Non-Urgent Crossing Status: Found UCIP Comments: Vegetation at inlet and wooden box failing at LS toe. FIELD_STRUCT_DESC: 42-inch corrugated metal drainage pipe through the levee, 12 feet below the crown. Flap gate on the waterside (WS) end. Concrete headwalls on both ends with a wooden retaining wall drop inlet at the landside (LS) toe. (42-inch pipe [HLM 0.55] retained under Automatic Board Order (ABO) issued as Permit No. 11492, 1975 - Dennis P. McCarthy). [Additional Reference(s): DWR Levee Log, 2005. USACE Sacramento O&M Manual 506.2, August 1961, (HLM 0.55) Drawing No. CC-4-4-29]. FS Date: 1/22/2014

Concrete headwall and flapgate visible at WS berm.

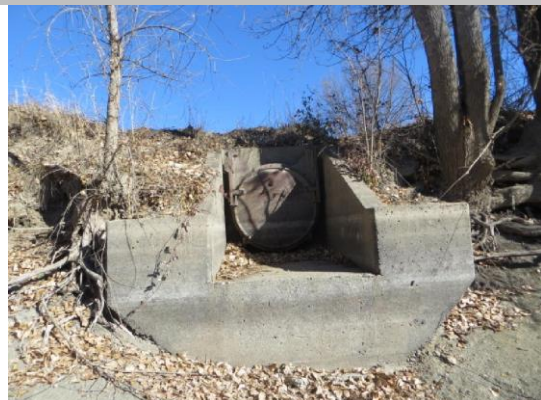
Photo 3 of 3 : UCIP\_FA\_2018\_27863\_51540.jpg

Concrete headwall and flapgate visible at WS berm.

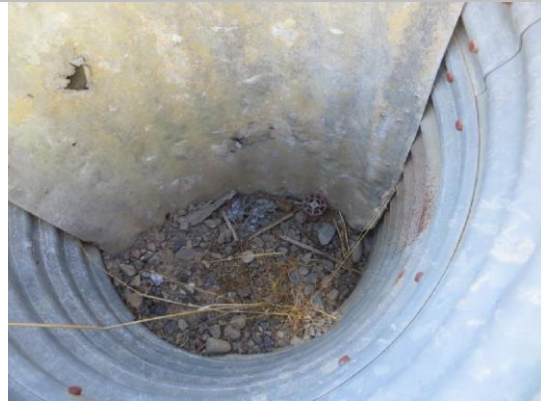
Photo 1 of 3 : UCIP\_FA\_2018\_27891\_51587.jpg

Comment Code					
Inspector Comment					
FS_ID:27891 DS_ID:21219 EP_NO: 11492 Repair Type: Non-Urgent Crossing Status: Indicator Found UCIP Comments: Appears abandoned and if so should be done so properly. FIELD_STRUCT_DESC: 4-inch steel irrigation pipe through the levee, 2.5 feet below the crown. Siphon breaker in 24-inch corrugated metal riser unit on the landside (LS) shoulder. Pump on concrete platform on the waterside (WS). Hose chute and concrete stairway on the WS slope. (Pipe retained under Automatic Board Order (ABO) issued as Permit No. 11492, 1975 - Dennis P. McCarthy). [Additional Reference(s): DWR Levee Log, 2005]. FS Date: 1/22/2014

Valve visible at bottom of CMP riser on LS shoulder.

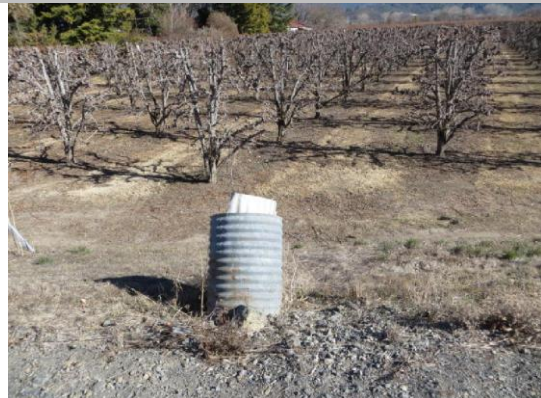
Photo 2 of 3 : UCIP\_FA\_2018\_27891\_51586.jpg

Siphon at LS shoulder inside 24-inch CMP riser.

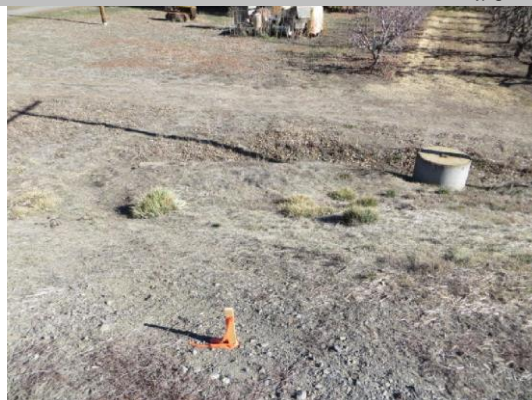
Photo 1 of 3 : UCIP\_FA\_2018\_27892\_51591.jpg

Comment Code						
Inspector Comment						
FS_ID:27892 DS_ID:21220 EP_NO: 11492 Repair Type: Non-Urgent Crossing Status: Found UCIP Comments: Some sediment buildup at inlet. FIELD_STRUCT_DESC: 24-inch corrugated metal drainage pipe through the levee, 10 feet below the crown. Flap gate on the waterside (WS) end. Concrete headwalls on both ends. Concrete spillway on the WS slope to bottom of channel. (24-inch pipe [HLM 0.79] retained under Automatic Board Order (ABO) issued as Permit No. 11492, 1975 - Dennis P. McCarthy). [Additional Reference(s): DWR Levee Log, 2005. USACE Sacramento O&M Manual 506.2, August 1961, (HLM 0.79)]. FS Date: 1/22/2014

Concrete headwall visible next to concrete standpipe on LS toe.

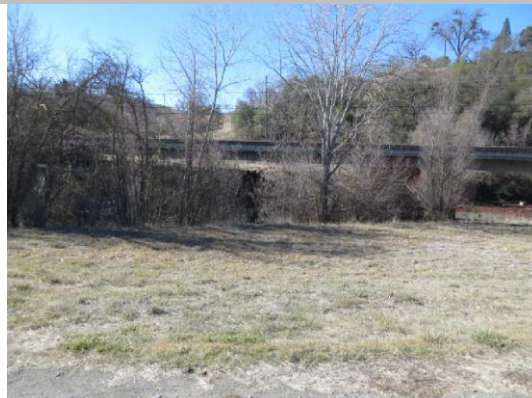
Photo 2 of 3 : UCIP\_FA\_2018\_27892\_51590.jpg

Comment Code						
Inspector Comment						
FS_ID:27892						
DS_ID:21220						
EP_NO: 11492						
Repair Type: Non-Urgent						
Crossing Status: Found						
UCIP Comments: Some sediment buildup at inlet.						
FIELD_STRUCT_DESC: 24-inch corrugated metal drainage pipe through the levee, 10 feet below the crown. Flap gate on the waterside (WS) end. Concrete headwalls on both ends. Concrete spillway on the WS slope to bottom of channel. (24-inch pipe [HLM 0.79] retained under Automatic Board Order (ABO) issued as Permit No. 11492, 1975 - Dennis P. McCarthy). [Additional Reference(s): DWR Levee Log, 2005. USACE Sacramento O&M Manual 506.2, August 1961, (HLM 0.79)].						
FS Date: 1/22/2014

Concrete outfall visible off WS berm.

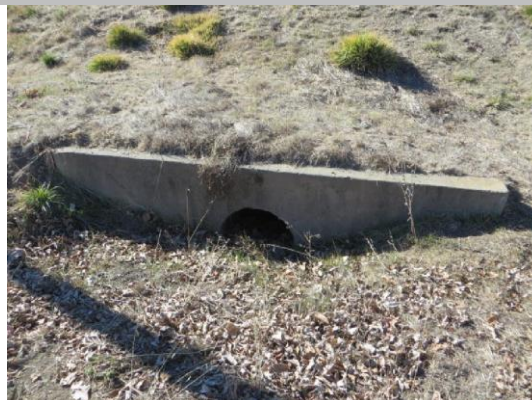
Photo 3 of 3 : UCIP\_FA\_2018\_27892\_51589.jpg

Concrete headwall visible at LS toe.

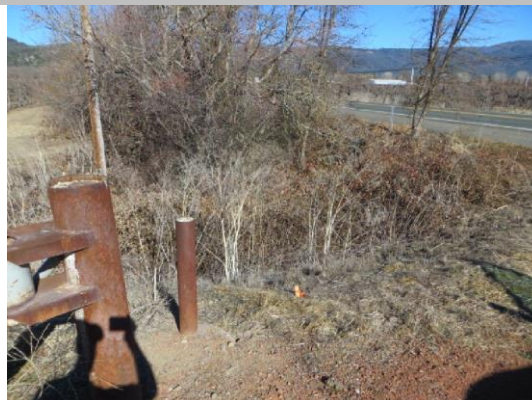
Photo 2 of 3 : UCIP\_FA\_2018\_27894\_51598.jpg

Concrete headwall on LS toe.

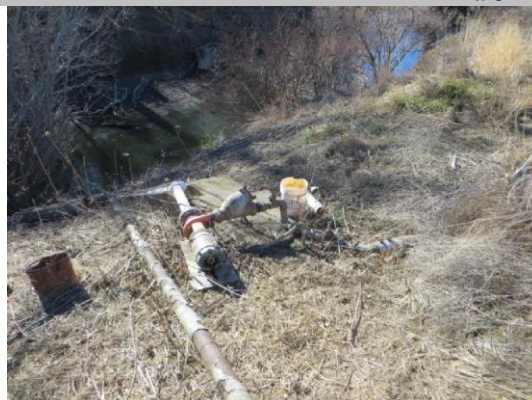
Photo 1 of 3 : UCIP\_FA\_2018\_27903\_51622.jpg

Comment Code					
Inspector Comment					
FS_ID:27903 DS_ID:21248 EP_NO: 11488 Repair Type: Non-Urgent Crossing Status: Indicator Found UCIP Comments: Siphon breaker standpipe knocked over and covered with dirt. Pipe and appurtenances appear to be in disrepair. Gate valves next to tank broken. FIELD_STRUCT_DESC: 6-inch steel irrigation pipe through the levee, 2.5 feet below the crown. Siphon breaker in 24-inch corrugated metal riser unit on the landside (LS) shoulder. Screw gate on the waterside (WS) slope next to pump and 300-gallon tank. (Pipe retained under Automatic Board Order (ABO) issued as Permit No. 11488, 1975 - Robert F. and Mary E. Wheeler). [Additional Reference(s): USACE Sacramento O&M Manual 506.2, August 1961, (HLM 1.02)]. FS Date: 1/22/2014

Pump at concrete pad on WS berm.

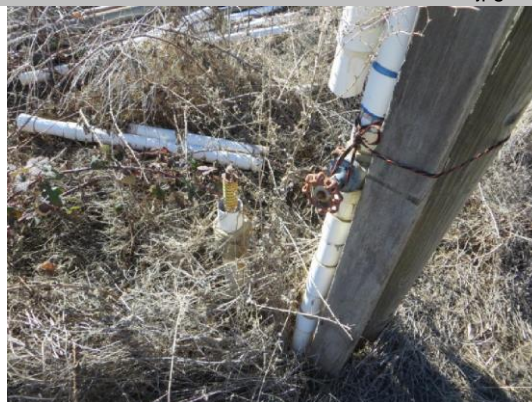
Photo 3 of 3 : UCIP\_FA\_2018\_27903\_51620.jpg

Comment Code						
Inspector Comment						
FS_ID:27903 DS_ID:21248 EP_NO: 11488 Repair Type: Non-Urgent Crossing Status: Indicator Found UCIP Comments: Siphon breaker standpipe knocked over and covered with dirt. Pipe and appurtances appear to be in disrepair. Gate valves next to tank broken. FIELD_STRUCT_DESC: 6-inch steel irrigation pipe through the levee, 2.5 feet below the crown. Siphon breaker in 24-inch corrugated metal riser unit on the landside (LS) shoulder. Screw gate on the waterside (WS) slope next to pump and 300-gallon tank. (Pipe retained under Automatic Board Order (ABO) issued as Permit No. 11488, 1975 - Robert F. and Mary E. Wheeler). [Additional Reference(s): USACE Sacramento O&M Manual 506.2, August 1961, (HLM 1.02)]. FS Date: 1/22/2014

filler valves on LS toe.

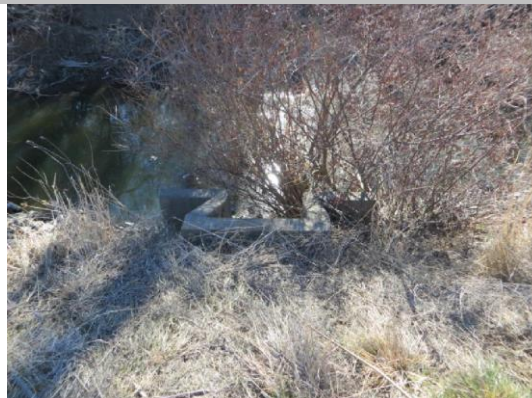
Photo 1 of 3 : UCIP\_FA\_2018\_27943\_51642.jpg

LM Start	0.99	Rating **	M	Issue No.	27	
LM End	0.99	Issue Type +	Ma	Location *		
Category	Supplemental			GPS Latitude/Longitude		
				Start		End
Item	DWR UCIP LMA Responsibility			39.160117 °		39.160117 °
				-122.922144 °		-122.922144 °
DWR ID	21222					
Comment Code						
Inspector Comment						
FS_ID:27943 DS_ID:21222 EP_NO: 11488 Repair Type: Non-Urgent Crossing Status: Found UCIP Comments: Some vegetation buildup at inlet and outlet. FIELD_STRUCT_DESC: 24-inch corrugated metal drainage pipe through the levee, 14 feet below the crown. Flap gate on the waterside (WS) end. Concrete headwalls on both ends. (24-inch pipe [HLM 1.01] retained under Automatic Board Order (ABO) issued as Permit No. 11488, 1975 - Robert F. and Mary E. Wheeler). [Additional Reference(s): DWR Levee Log, 2005. USACE Sacramento O&M Manual 506.2, August 1961, (HLM 1.01)]. FS Date: 1/22/2014

Concrete Headwall on WS berm.

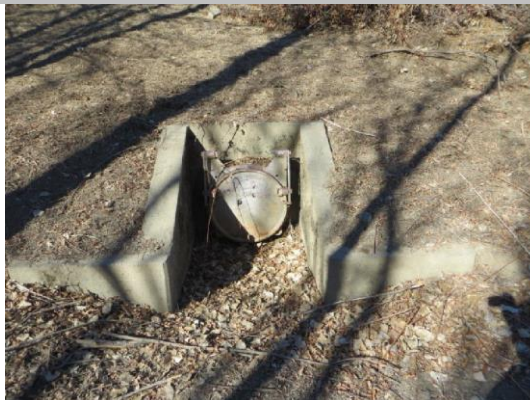
Photo 2 of 3 : UCIP\_FA\_2018\_27944\_51645.jpg

Comment Code						
Inspector Comment						
FS_ID:27944						
DS_ID:21223						
EP_NO: 11489						
Repair Type: Non-Urgent						
Crossing Status: Found						
UCIP Comments: Some sedimentation buildup at inlet and through pipe.						
FIELD_STRUCT_DESC: 24-inch corrugated metal drainage pipe						
through the levee, 12.5 feet below the crown. Flap gate on the						
waterside (WS) end. Concrete headwalls on both ends. (24-inch pipe						
[HLM 1.09] retained under Automatic Board Order (ABO) issued as						
Permit No. 11489, 1975 - Bank of Upper Lake). [Additional						
Reference(s): DWR Levee Log, 2005. USACE Sacramento O&M						
Manual 506.2, August 1961, (HLM 1.09)].						
FS Date: 1/22/2014

Flapgate and headwall visible on WS toe.

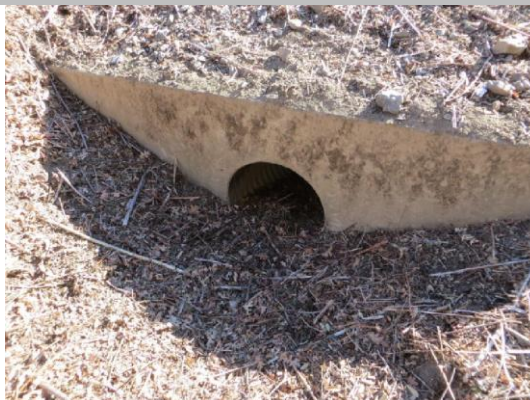
Photo 3 of 3 : UCIP\_FA\_2018\_27944\_51644.jpg

Concrete headwall on LS toe.

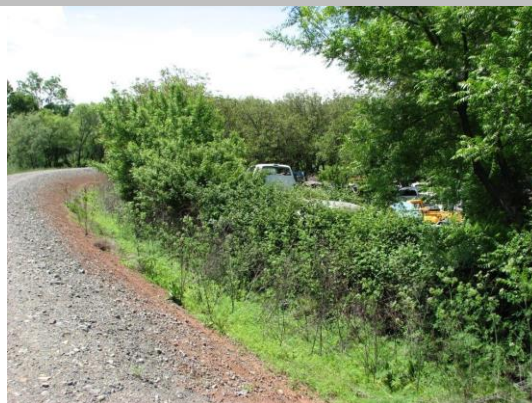
Photo 1 of 1 : FA\_2018\_NA0009\_5\_12\_20180905\_00003.jpg

LM Start	1.07	Rating **	U	Issue No.	12
LM End	1.13	Issue Type +	Ma	Location *	LS
Category	Earthen Levee			GPS Latitude/Longitude	
				Start	End
Item	Vegetation			39.159787 °	39.159616 °
				-122.923517 °	-122.924645 °
DWR ID	DWR_NA0009_03_s_2016_12				
Comment Code					
V2 : Remove the wild growth other than native grasses from the levee slopes.					
Inspector Comment					
Dense vegetation growing on fence blocks visibility and access.

5/2/2016: Dense bushes and vines covering fence along vehicle junk yard.

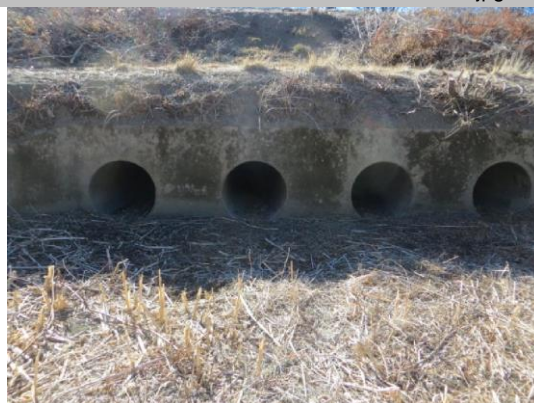
Photo 1 of 3 : UCIP\_FA\_2018\_27964\_51665.jpg

LM Start	1.23	Rating **	A/W	Issue No.	30
LM End	1.23	Issue Type +	Ma	Location *	
Category	Supplemental			GPS Latitude/Longitude	
				Start	End
Item	DWR UCIP LMA Responsibility			39.160369 °	39.160369 °
				-122.926208 °	-122.926208 °
DWR ID	21237				
Comment Code					
Inspector Comment					
FS_ID:27964 DS_ID:21237 EP_NO: 11489 Repair Type: No Action Needed Crossing Status: Found UCIP Comments: FIELD_STRUCT_DESC: 2 of 4: 36-inch corrugated metal drainage pipe through the levee, 15.2 feet below the crown. Flap gate on the waterside (WS) end. Concrete headwalls on both ends. (four 36-inch pipes [HLM 1.25] retained under Automatic Board Order (ABO) issued as Permit No. 11489, 1975 - Bank of Upper Lake). [Additional Reference(s): DWR Levee Log, 2005. USACE Sacramento O&M Manual 506.2, August 1961, (HLM 1.25)]. FS Date: 1/22/2014

Pipe and headdwall on LS toe.

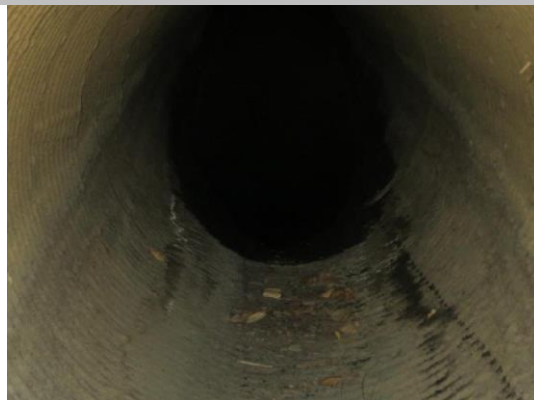
Photo 2 of 3 : UCIP\_FA\_2018\_27964\_51664.jpg

Pipe from LS toe.

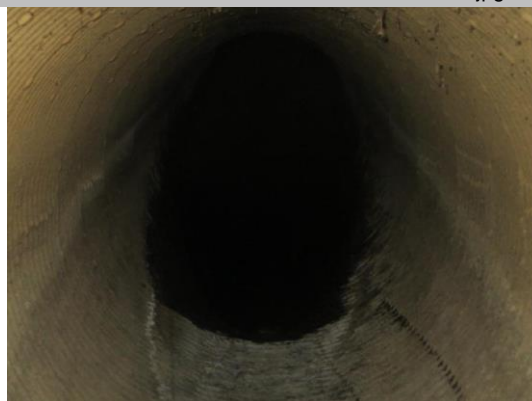
Photo 2 of 3 : UCIP\_FA\_2018\_27965\_51667.jpg

LM Start	1.24	Rating **	A/W	Issue No.	31 (cont)	
LM End	1.24	Issue Type +	Ma	Location *		
Category	Supplemental			GPS Latitude/Longitude		
				Start	End	
Item	DWR UCIP LMA Responsibility			39.160377 °	39.160377 °	
				-122.926223 °	-122.926223 °	
DWR ID	21238					
Comment Code						
Inspector Comment						
FS_ID:27965 DS_ID:21238 EP_NO: 11489 Repair Type: No Action Needed Crossing Status: Found UCIP Comments: FIELD_STRUCT_DESC: 3 of 4: 36-inch corrugated metal drainage pipe through the levee, 15.2 feet below the crown. Flap gate on the waterside (WS) end. Concrete headwalls on both ends. (four 36-inch pipes [HLM 1.25] retained under Automatic Board Order (ABO) issued as Permit No. 11489, 1975 - Bank of Upper Lake). [Additional Reference(s): DWR Levee Log, 2005. USACE Sacramento O&M Manual 506.2, August 1961, (HLM 1.25)]. FS Date: 1/22/2014

Pipe from LS toe.

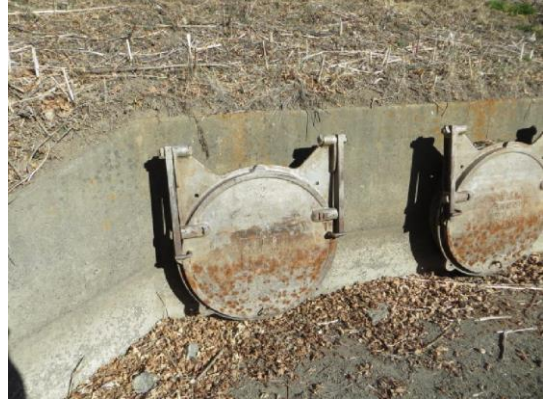
Photo 3 of 3 : UCIP\_FA\_2018\_27967\_51669.jpg

LM Start	1.24	Rating **	A/W	Issue No.	32 (cont)
LM End	1.24	Issue Type +	Ma	Location *	
Category	Supplemental			GPS Latitude/Longitude	
				Start	End
Item	DWR UCIP LMA Responsibility			39.160386 °	39.160386 °
				-122.926239 °	-122.926239 °
DWR ID	21239				
Comment Code					
Inspector Comment					
FS_ID:27967 DS_ID:21239 EP_NO: 11489 Repair Type: No Action Needed Crossing Status: Found UCIP Comments: FIELD_STRUCT_DESC: 4 of 4: 36-inch corrugated metal drainage pipe through the levee, 15.2 feet below the crown. Flap gate on the waterside (WS) end. Concrete headwalls on both ends. (four 36-inch pipes [HLM 1.25] retained under Automatic Board Order (ABO) issued as Permit No. 11489, 1975 - Bank of Upper Lake). [Additional Reference(s): DWR Levee Log, 2005. USACE Sacramento O&M Manual 506.2, August 1961, (HLM 1.25)]. FS Date: 1/22/2014

Flapgate on concrete headwall on WS toe.

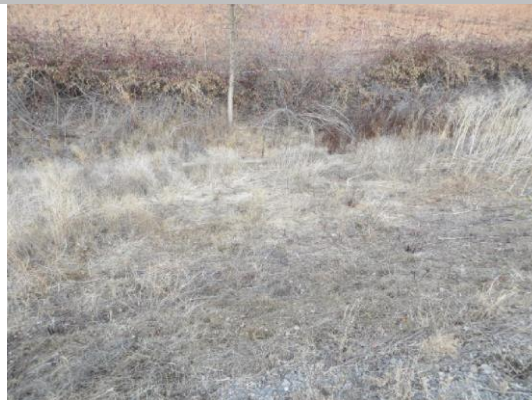
Photo 1 of 3 : UCIP\_FA\_2018\_26947\_49793.jpg

LM Start	0.14	Rating **	A/W	Issue No.	18
LM End	0.14	Issue Type +	Ma	Location *	
Category	Supplemental			GPS Latitude/Longitude	
				Start	End
Item	DWR UCIP LMA Responsibility			39.176422 °	39.176422 °
				-122.909978 °	-122.909978 °
DWR ID	21236				
Comment Code					
Inspector Comment					
FS_ID:26947					
DS_ID:21236					
EP_NO: 11499					
Repair Type: No Action Needed					
Crossing Status: Found					
UCIP Comments:					
FIELD_STRUCT_DESC: 1 of 2: 42-inch corrugated metal drainage pipe through the levee, 12 feet below the crown. Flap gate on the waterside (WS) end. Concrete headwalls on both ends. (two 42-inch pipes [HLM 0.14] retained under Automatic Board Order (ABO) issued as Permit No. 11499, 1975 - Howard D. and Eunice A. Norton). [Additional Reference(s): DWR Levee Log, 2005. USACE Sacramento O&M Manual 506.2, August 1961, (HLM 0.14)].					
FS Date: 1/9/2014

Concrete headwall visible on LS toe.
